CHIRP FEEDBACK

Issue No: 23

Summer 2009

A Maritime Safety Newsletter

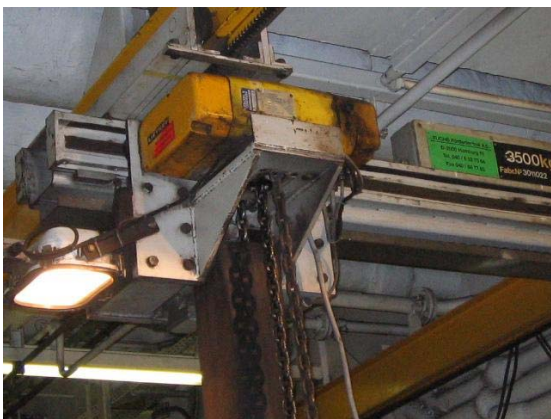
The overhead crane in its gantry.

The turning gear operator is to be located on the top of the engine adjacent to the crane operator. A suitable initial length of chain is to be paid out before the engine is turned. An observer posted at the crankcase door will signal when the piston has reached BDC.

The chain and crane operator are now in close physical contact. Two pairs of eyes are now on the critical task of monitoring crane chain tension. The turning gear can be stopped immediately should a situation arise. This negates the risk of critical communication delay, from the top to the base of engine.

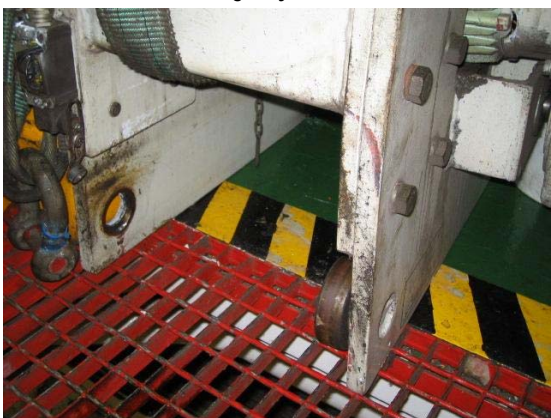
End plates of gantry splayed out.

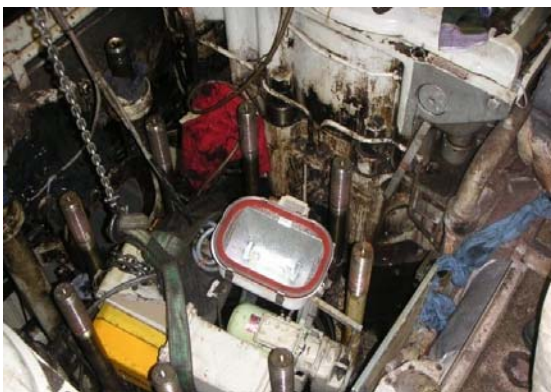
The crane mechanism lying on top of the engine.
