CHIRP MARITIME FEEDBACK

Issue No: 34

01/2014

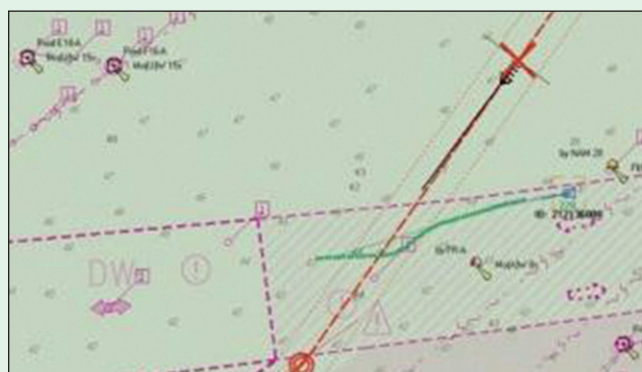
Report text: We are loaded tanker Length 242m breadth 44m, draft 15m bound from Skagen to Rotterdam. Due to dense fog we proceed at 11.2 kts. From the East there is in traffic lane approaching vessel 'A' on a collision course. Our heading 220 and their heading is about 260. Collision is imminent and we called them ask to go astern of as per Collision Rules. They refuse and tell that it's too late for them! They tell us that they will go ahead of us, crossing our bow. We can easily see that it is not possible as they have only 8.7 kts speed. Our only possibility is stop engine and let the speed go down. Finally they changed their course more to port as observed from the radar track plotting pictures. If we had not stopped our engine, they never would have passed our bow. We had three radars plotting continuously their manoeuvres and situation was critical all the time and that's why we decided to ask what they are going to do. Our speed was only about 5kts when they finally passed our bow.

CHIRP contacted the ship owner of ship 'A'. They replied with a report from their ship's officer of the watch (OOW) who confirmed the time and position as per the reporter's statement. The OOW observed the reporter's ship to be making a speed of 9.6 knots with ARPA plot showing an opening bearing to his starboard side with CPA 1.0 miles. The OOW claims his course was 263 and speed 8.7–8.9 knots and saw the ship abeam at 3–4 Miles distance, not in thick fog as claimed by the reporter. The OOW also did not hear any fog signals. He called the reporter's ship and told him of his intentions to alter course to port to increase the CPA to 1.5 miles. The reporter asked that he pass astern but the OOW replied it was too late to undertake that manoeuvre. The reporter's claim to have stopped his ship was not observed. The OOW on ship 'A' concludes he believes in such situations, altering course and good cooperation is more effective to avoid risk of collision, especially in good visibility and not dense fog. Also there was sufficient sea room with no closer vessel at that time.

CHIRP Comment: At a previous Maritime Advisory Board (MAB) meeting, a comment was made that exercises on the ship simulator, show that navigators are sometimes reluctant to make a large alteration to starboard to keep clear of a vessel on or near to their starboard beam. This appears to be such a case. It might also be that, as Vessel 'A' was close to the Northern edge of the Deepwater Route, the OOW may have been reluctant, perhaps unnecessarily, to go outside it.

The MAB reviewed the statements from both ships and they noted a number of inconsistencies between the reports from each ship, most notably one ship claims to be in dense fog and the other having clear visibility. However the statement from the OOW on the Ship 'A' reveals he saw red lights on his starboard side and therefore he was the crossing vessel and should have taken early avoiding action.

- The Officer of the watch (OOW) should have complied with the Collision Regulations and taken early and decisive action;
- OOW should have called the Master when the close quarter's situation appeared to be imminent;
- The company should undertake OOW training in order to improve the level of understanding of the Collision Regulations, and
- The company should consider the adequacy of their auditing of Bridge operations.

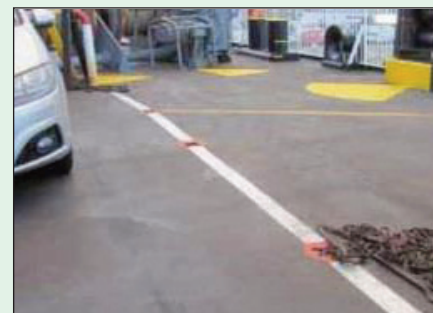
Report text: Loading of private cars was on the wet, exposed extreme rear outside upper deck of this Ro-Ro ferry leaving very young children and infirm passengers to cross a wet, slippery obstacle strewn deck in driving rain and very high winds. There was ample sheltered, dry vehicle accommodation that remained unused throughout the passage. The loading supervising crewman could only explain the loading plan as being due to the crew having no idea how many vehicles were to be loaded – even though vehicles had been checked in for about an hour before loading – and told me I needed to ask the loading officer if I wasn't happy with this explanation. I requested, via the Customer Service Officer if I might meet with the loading Officer once underway – but the Loading officer refused to meet with me to explain the reasons for this hazardous choice, and instructed the CS Officer to issue a complaint form.

- The open deck in question is a certified passenger vehicle deck under Class and Flag rule.
- The deck surface is specially coated with anti-skid layer, deck fixtures are limited to elephant foot fixtures which are half circular shape painted with high visibility paint.
- For the day in question, the vessel was fully booked with passenger vehicles and trailers. The space referred to was likely to be a space left intentionally for a booked trailer that was still to be loaded, but stowed to ensure the passenger vehicles are able to leave at the port of arrival before the trailers.
- Vehicle decks are manned by a number of deck crew who are obliged to assist those who appear to need help
