# CHIRP MARITIME FEEDBACK

Issue No: 35

02/2014

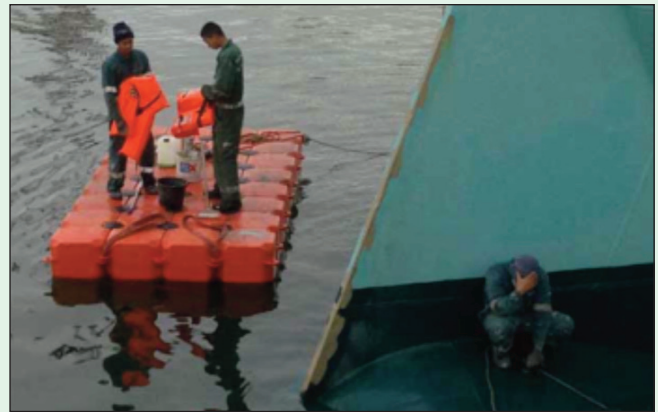
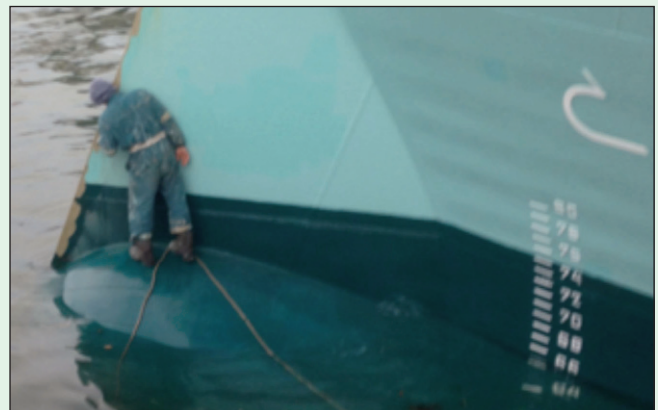
**Report text:** Pilot cutter was on routine operation when the coxswain noted a small punt with two men on it painting the vessel's bow. Concerned for the crewmen's safety as there was always passing traffic/wash etc. and the fact they were not wearing any buoyancy aid, the coxswain telephoned his supervisor to advise of the situation.

The port supervisor arrived on the quay and noted the punt in the water. Also on the inboard side and out of view of the pilot cutter was a crewman perched on the bulb of the bulbous bow of the ship. At the same time an officer from the ship arrived on the quayside to enquire what was going on.

Our port supervisor pointed to the operation that was happening and highlighted the fact that none of the three men (two on the punt and one on the bow) were wearing any buoyancy aid. The officer seemed unconcerned stating that his crew can swim. Buoyancy Aids (Life Jackets) were supplied and the work on the punt continued and the man on the bow came ashore.

The use of the lifejacket should be questioned as they are for lifesaving purposes and not for this type of work.

There should really be proper work wear buoyancy aids.

**CHIRP Comment:** The harbour staff stopped the job due to the concern for the seafarer's safety, in particular the person could have been washed off the bow from the wake of a passing vessel and then hit his head or suffered hyperthermia from being in the cold water.

The report illustrates a poor application of the SMS and the need for the use of risk assessment and a permit to work when working over side. Charterers using their own company branding on Owner/Master controlled ships operating in commercial pools should consider the need for compliance with the Charterer's stated QHSE policies and in particular have an equivalent SMS, whether or not they provide the crew doing the work.

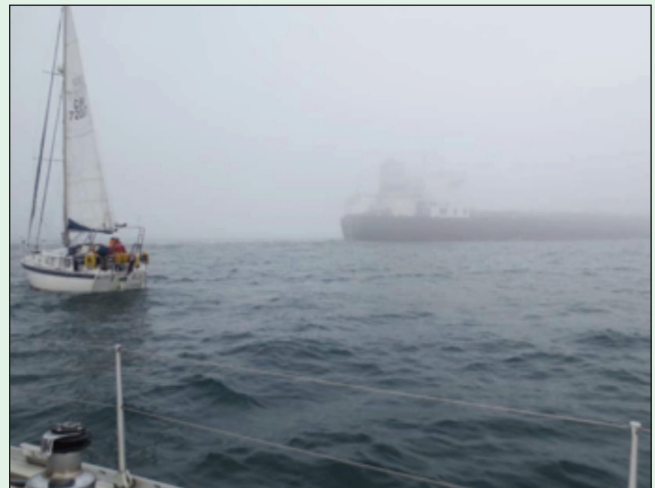
CL's radar was set with course up (not the more convenient north up) and so when we altered course all the tracks of radar contacts changed and in the next few minutes it was not clear if the true courses of any of the contacts had changed. However we felt confident that from the previous plot we should be safe. We then suddenly saw a large indistinct visual contact on our port beam at a range of two to three cables. At first we thought this was a ship heading west but after a few moments we saw a bow wave and realised it was a large ship heading straight for us. Seconds later the helmsman saw that we were very fine on the ship's starboard bow and altered course violently to port reversing our course from east to west, D following. A large, Chinese registered bulk carrier (BC) just passed us at a distance of less than 100 yards (see photo attached, taken from D). This was too close for comfort.

**Overview:** We had altered course from north to east to avoid the BC, which we had plotted as steering west. However as we came into close quarters she was steering south so she had clearly altered course. Our radar plotting on CL was not accurate enough to have seen this although on D they had just noticed this but did not have time to notify CL. It seems clear that BC had altered course to port and to a course of south at the same time as we had altered to a course of east. We had both altered from one set of converging courses to another at the same time!

It seems clear that BC had contravened this rule. CL's radar plotting was weak being 'head up'. This was perfectly adequate to cope with CL being on a steady course, but with 6–7 contacts and a major alteration of course, it proved inadequate. However CL/D complied with Rule 19 by altering course to starboard when we considered that a risk of collision existed whereas BC contravened Rule 19 by altering course to port for a vessel forward of the beam.
