# CHIRP FEEDBACK

Issue No: 6

A Maritime Safety Newsletter

from **CHIRP** the Confidential Hazardous Incident Reporting Programme

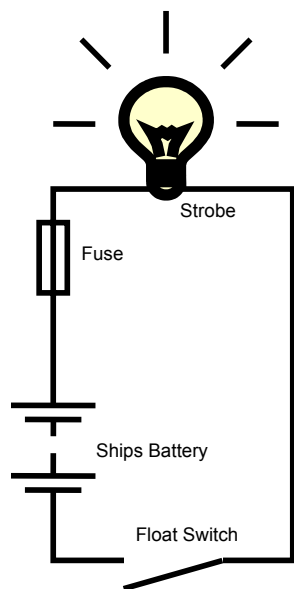
**Report Text:** A trawler recently changed hands and a high level alarm conforming to the attached schematic was ordered to be fitted before the vessel sailed.

The new owner agreed and put the job in hand, but unfortunately the vessel sprang a leak whilst alongside the quay and flooded the engine room causing considerable damage before the installation was completed. The leak was caused by localised corrosion where pig iron ballast was in contact with the hull.

The strobe would have been noticed by harbour security that night had the yard electrician completed his job a little faster!

**CHIRP Comment: Flooding that goes undetected regularly leads to loss of the vessel with serious risk to life. The schematic below is referred to in the report and intended as a secondary alarm, directly wiring the ship's batteries to a strobe on the wheelhouse deck-head via a float switch.**

Simple and cheap for any size of vessel; below shaft level, high enough to test easily and less likely to generate annoying false alarms, but allowing adequate time to sort out most problems and always on; even in port.

It is a common sense solution, but also the law; the 15-24m Code states that ships must have either an independent secondary alarm or a "fail safe" primary system.
