# CHIRP FEEDBACK

Issue No: 15

2/2007

A Maritime Safety Newsletter

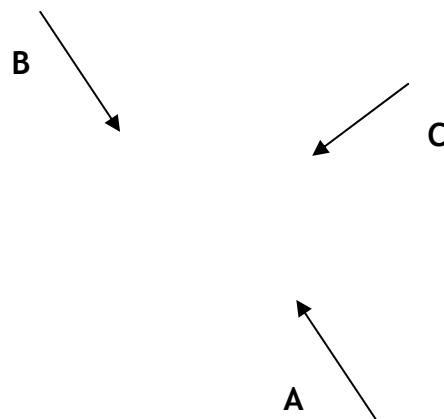
**COLLISION AVOIDANCE – MULTIPLE CROSSING**

Vessel (C) Course: 225 (T) in TSS  
 Vessel speed: Approx. 16,5 knots

It was noted that a ferry (A) was crossing the channel at right angles to the flow of traffic. It was noted that this vessel would have a CPA of 0' initially and that the speed of this vessel was initially approximately 16.5 knots. This vessel was on my port bow and thus I was the "stand on" vessel. Initial distance of this vessel approximately 5.5 miles

Simultaneously, it was noted that another ferry (B) was transiting in the opposite direction to (A). This vessel also had a CPA of 0' and as she was on my starboard bow, I was obliged to keep out of her way.

The situation was monitored closely and it became apparent that the initial actions of vessel (A) were insufficient to avoid a close quarter situation with own vessel. I attempted to contact vessel (A), via VHF Channel 16. My calls elicited nil response despite my repeating the call on a number of occasions and using all methods to identify myself.

It was then noted that (A) increased her speed as a method of avoiding a close quarter situation and would pass ahead of us at a distance of approximately one mile. However, I was still having a 0' CPA with the (B) who, quite correctly, maintained her course and speed throughout. I attempted further contact via VHF channel 16 with (A) but once again without response. I wanted to alert the O.O.W. on that vessel that his/her actions were causing me grave embarrassment with (B) and that as a result of the choice to increase speed, I was unable to alter course, as would be required, to avoid (B).

Once it was apparent that a potential 'close quarter' situation was developing, I engaged hand steering and when (A) was observed ahead of my vessel, I altered my course to starboard by an eventual 25 degrees enabling the (B) to pass ahead of me safely.

- **The passing distances involved are not unusual for this busy area and ferry bridge teams are likely to be accustomed to them, however, they should be aware that other vessels, who transit less frequently, may be concerned by their proximity and should take measures to make their intentions clear.**
- **Whilst VHF use may be appropriate on occasion, the time used by vessel (C) trying to establish contact by VHF may have been used more effectively in assessing and reacting to the situation. Subsequent investigations indicated (C) may not have been transmitting in any event.**
- **A prompt alteration of course or reduction in speed by vessel (C) may have been the best solution and would have required ferry (A) to reassess its own actions.**
