MARITIME FEEDBACK

Issue No: 22

Spring 2009

A Maritime Safety Newsletter

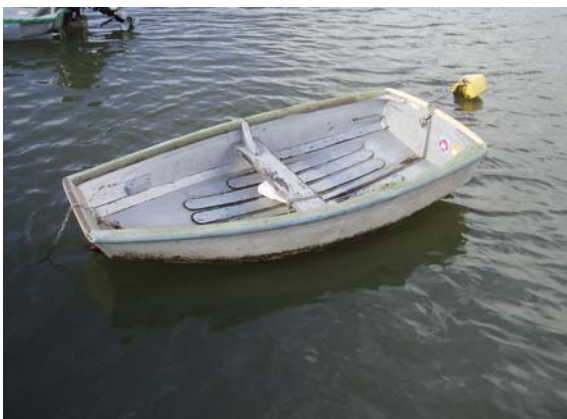
The three men were commercial fishermen who had been crossing the river in their small tender when it capsized. They had no lights and were not wearing lifejackets.

The photo shows the small tender after it was recovered.

Lessons Learned: Wear a life jacket. Don't overload. Have lights.

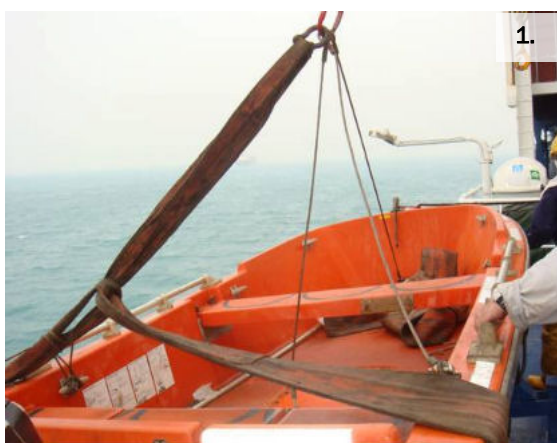
The boat's crew of four were wearing boiler suit, safety boots, helmet and life jacket. The boat was swung out with the four crew members on board. As lowering commenced, the eye-plate on the port side aft suddenly detached from the hull. The boat was left hanging starboard side up. Three of the boat's crew plummeted into the sea, a distance of approximately 12 metres. The officer in charge of the boat was left hanging on. Having ascertained that this officer was able to remain secure, the boat was lowered to the water and the three crew members were recovered, fortunately without long-term injury.

Subsequent examination showed that all four stainless steel bolts had failed.

Photo1: The rescue boat after it had been recovered back on board. The large webbing strap had been rigged whilst the boat was in the water to replace the third part of the bridle which is hanging loose.

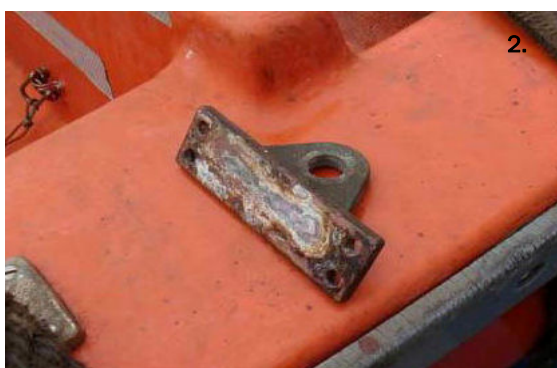
Photo 2: The detached eye-plate.

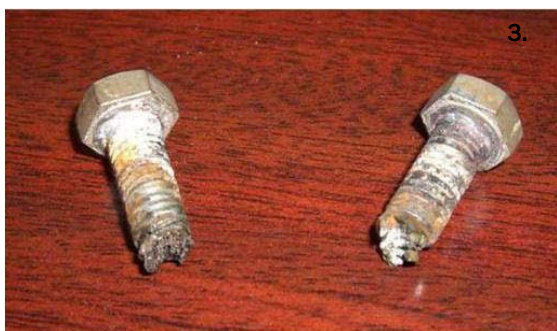
Photo 3. Two of the failed bolts. The other two had similarly failed.

The ship's manager arranged an urgent survey with the boat manufacturer on two vessels with the same rescue-boats of similar age. The bolts and eye-plates were found to be in satisfactory condition. At the time of publication of this newsletter, the manufacturer is analysing the broken bolts to determine the cause of the failure. Possibilities include a production error with these bolts or galvanic action.
