# CHIRP FEEDBACK

Issue No: 9

A Maritime Safety Newsletter

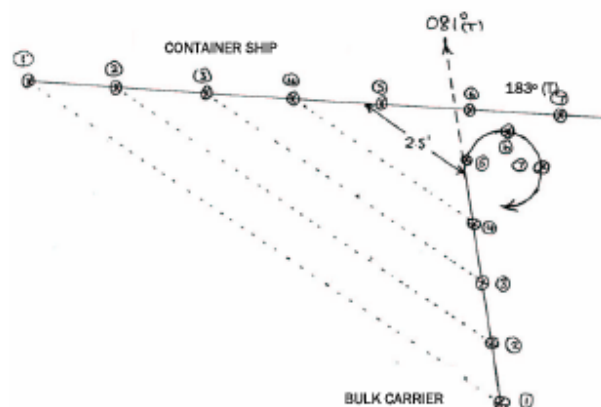
**Report Text:** Vessel A, loaded bulk carrier, draught 17.3 metres (from AIS), was approaching the western end of a TSS east bound lane and vessel B was a container vessel altering to a southerly course after leaving the westbound lane.

It became clear that the two vessels were entering a very close quarters situation.

At range 3.5 miles, when no apparent action had been taken by the "give way" container vessel, she was called by name on VHF Ch.16, but did not reply. At range 3.0 miles, there was no action taken and no reply to another VHF call.

At 2.5 miles range a round turn to starboard was initiated by the "stand-on" loaded bulk carrier.

When the bulk carrier was approximately 60 degrees off its original course, the container vessel called it on VHF Ch.16 and asked "What are your intentions?"

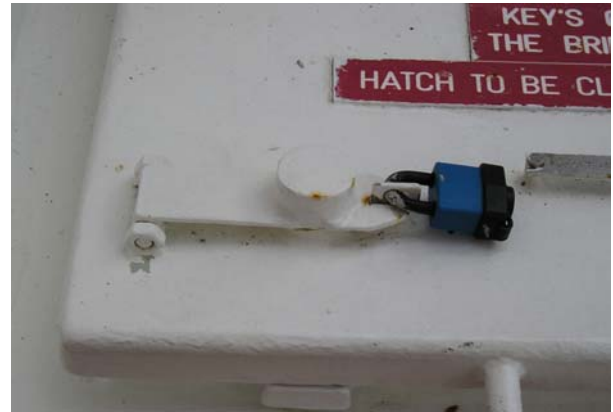
First, what appears to be a padlocked escape hatch is not all it seems.

On closer examination it was found that the external dog on the escape hatch had been removed and a padlocked cover installed. From inside the escapee would not notice any change; having to release the same number of dogs.

If access to the engine room was required via the escape the officer of the watch and deck ratings all had keys that fitted the padlock. The cover could be released and a spanner used on the dog's spindle to release the dog.

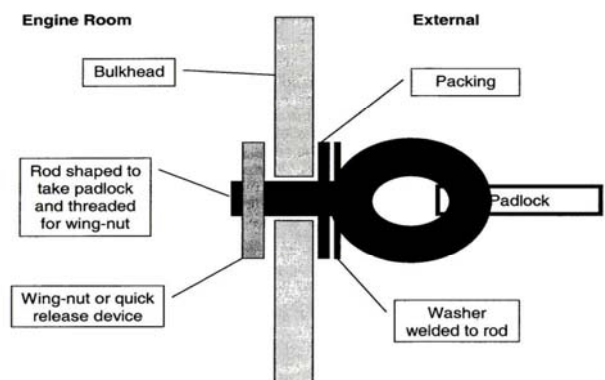
Here is another example demonstrating an emergency means of access through a padlock key control system and an internal quick release device.

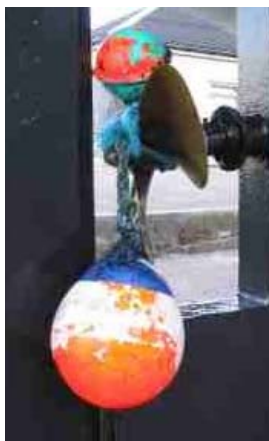
**Report Text:** My wife and I were in our sailing boat departing the harbour which has a tricky entrance with cross-tides and lengthy transits through rock strewn areas marked by infrequent channel marker posts. Approaching the final stages of the pilotage under engine, we noted a collection of pot marker buoys scattered in the entrance. Having made a course correction to avoid the pot markers, we concentrated again on navigation. A short while later, there was a bang and the boat started to slow down although the engine kept running. It was apparent that we had lost drive and we were being swept towards rocks. We completed a rapid sail hoist and just managed to achieve control and sail clear of the entrance. Subsequently, we completed an overnight sail back to a marina for repairs.

The damage was a sheared flexible drive coupling, a bent propeller shaft and a wrecked shaft seal requiring a 10 day haul-out and repairs totalling £2000. This marker buoy turned out to be a style we had not encountered before with a large buoy at the top of the riser and a small pick-up buoy at the end of a long length of floating line. I believe that we had steered between the main buoy and the pick-up buoy. This incident happened in benign conditions and we managed to look after ourselves. In less clement weather or darker conditions, the incident could easily have an unpleasant outcome. I
