CHIRP MARITIME FEEDBACK

Issue No: 37

04/2014

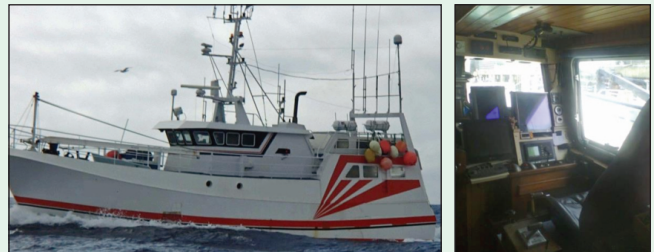
Steaming 192° at 9.5 knots between two fishing operations of 8.8 miles apart. Nothing seen on the radar, late afternoon sunshine glaring off the sea on the starboard side. Myself and one other crewman were in the wheelhouse. I passed the watch over with "Nothing to report", no radar targets or visual targets and went to the engine room to top up the daily service tank and was back in the wheelhouse within 10 minutes. There was nothing to report until a VHF call on channel 16 which was answered by myself, bringing to our attention a close quarter situation, where the yacht was visibly seen astern of us."

CHIRP Comment: The root cause of the close quarters situation was the fishing vessel not keeping a vigilant look-out. A contributing cause may have been the yacht not being seen due to the glare from the sun. With a condition of clear visibility, the watch keeper on the fishing vessel probably saw no reason to keep a close radar watch. The fishing vessel owner's prudent considerations of the ergonomics of bridge design and anti glare precautions taken were noted.

However I very much appreciate from first hand experience, comments after the event are easier to make. We have made an enquiry to a company, I will do my best to improve on the glare situation in the wheelhouse.

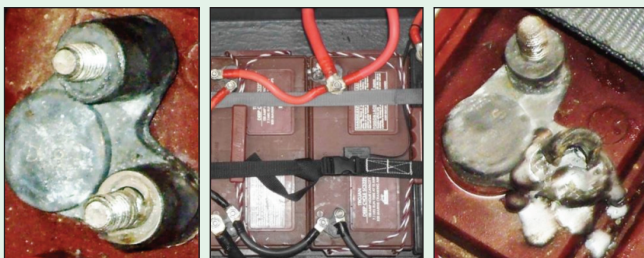
Report Text: Vessel built 2008 is an auxiliary sailing yacht. Incident: On leaving the marina berth for a day's duty as a Regatta Committee Boat in a borrowed boat, all the electrically-powered domestic accessories suddenly failed – no bow thruster, no anchor windlass, and no instruments. Problem: Subsequent investigation showed that the domestic battery pack (3 × 12V, 130 AH leisure batteries) had been linked in parallel, using wing nuts on the terminals. One wing nut had vibrated loose, causing arcing/sparking, hence localised heat increase, increased resistance and even higher temperatures. Final result was partial meltdown of the battery connecting terminal lug. The batteries are stowed under a screw-down panel under the galley floor.

CHIRP Comment: Contact with the boat manufacturer revealed this is a modification; the current design does not use wing nuts on batteries and uses locking nuts.

Lessons Learned: Check the tightness of battery terminals at regular intervals. Suggestion: NEVER use wing nuts only to connect battery terminals. (But the evidence is, that was the way in which the builder had supplied the boat!). Far better and safer to use hexagon head nuts with lock washers, tightened with a spanner.

MCA and NWA (National Workboat Association) Reference 8.5.4 States: Adequate provision should be made for securing electrical connections, e.g. use locking washers.

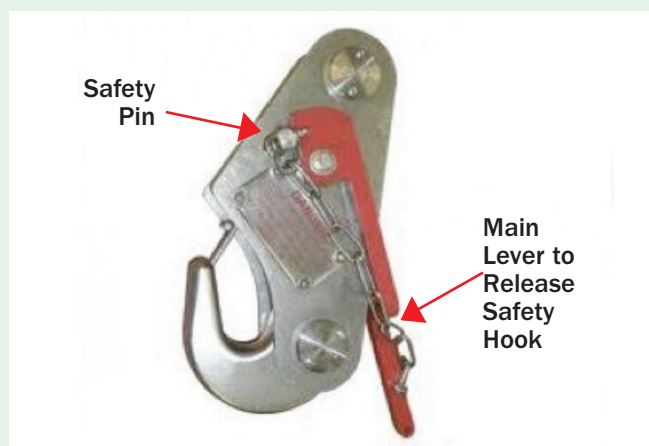
- There are two methods for releasing the rescue boat from the hook- On load (hanging) and Off load (Rescue boat is buoyant) release. Conducting an On load release is a high risk task and should be performed in a precise and controlled manner.
- The Safety Pin for an On load release is removed only after a safety assessment has been conducted and the conditions listed below have been met:
 - The rescue boat has been set at the correct (Safe) distance above the water;
 - Sea State assessed for release, and
 - Crew members are ready for release (ready in the boat).

- Off load release is the preferred method of deployment. On load release of rescue boats should only be performed when it is deemed the only option for deployment of the rescue boat;
- On load release should only be demonstrated while the rescue boat is supported either in the chocks or in the water, and
- The company is reviewing their training material.
