CHIRP MARITIME FEEDBACK

Issue No: 33

Autumn 2013

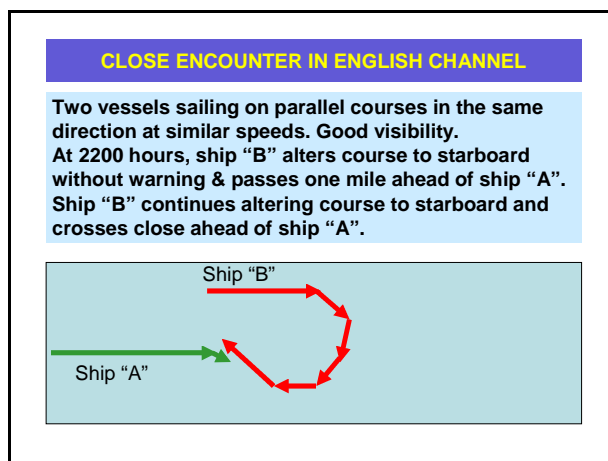
At 2200 hours vessel "B" started altering course to starboard. The green navigational light of vessel "B" became visible. It appeared that vessel "B" intended to cross about one mile ahead me. I made a VHF call identifying myself and my relative position to the vessel "B". I brought the attention of the OOW of "B" to the developing close quarter situation and requested him to take preventive action in accordance with Rule 15 of the ColRegs. At this moment the Captain of my ship arrived on bridge.

When the distance had decreased to 3 miles I made another VHF call. The OOW of "B" assured me that he would keep clear of me. Finally vessel "B" passed about 0.8 mile ahead of me.

From this moment everything happened very quickly. The situation had appeared to be safe as vessel "B" had crossed ahead of my bow and was approximately ten degrees on my starboard side, green to green, with a CPA of 0.5 mile. However she started altering course to starboard again, showing her red navigation light. We gave a signal of five short flashes on our lamp. Our Captain ordered rudder to starboard, so she crossed my bow for the second time at distance of approximately less than 0.5 nm ahead. The vessels passed port to

port at full speed and with a distance of 0.25 mile. After clearing my port side the other vessel altered course more to starboard and set her course towards Falmouth.

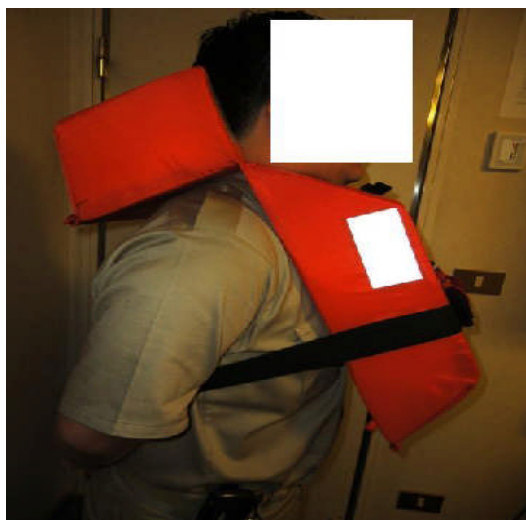
I totally agree with the concerns raised by our fellow mariner: this kind of lifejacket is really tight around the neck to the point that during drills, crew members wearing it felt uncomfortable in them and experienced a feeling of suffocation. In addition to that it makes quite difficult to perform basic safety related jobs i.e. preparing the lifeboats at embarkation deck, climbing up and down ladders and descending an MES chute.

Clearly these lifejackets passed the latest stringent tests required by SOLAS and have far better life saving capabilities. However they were not designed keeping in mind ease of wearing which is essential for those who work at sea.
