# CHIRP FEEDBACK

Issue No: 11

## What's in this Issue?

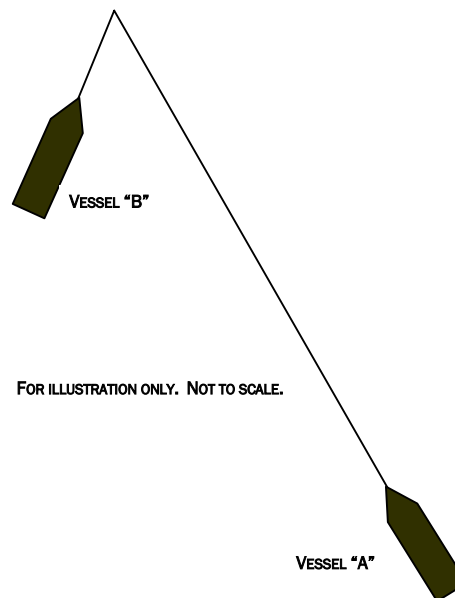
**CHIRP Comment:** This report contained insufficient detail to plot accurately, but the following diagram may be of assistance:

**Report Text:** The incident occurred in the afternoon in the Irish Sea. The weather was NW 5/6 with good visibility. Vessel "A" was on a NW'y course, ahead and to port was vessel "B" on a NNE'y course. Vessel "A" appeared to be the overtaking vessel coming up on the starboard quarter of "B" at a speed of about 20 kts. As they closed "A" called the "B" on #16, then onto #6 and the following conversation took place (this is not a word for word recollection of the conversation):
